# Management of a post-extraction socket in the aesthetic area with a Prama RF implant

Dr. Roberto Luongo, D.T. Leonardo Colella, Bari, Italy

A 35-year-old Caucasian patient suffered a 1.1 fracture due to a motorcycle accident. The incident resulted in a horizontal compound fracture of the dental element that was temporarily splinted to the adjacent teeth. Then the treatment plan included the extraction of the 1.1 with the simultaneous insertion of a post-extraction Prama RF implant and prosthetic rehabilitation with a crown and metal-free abutments.

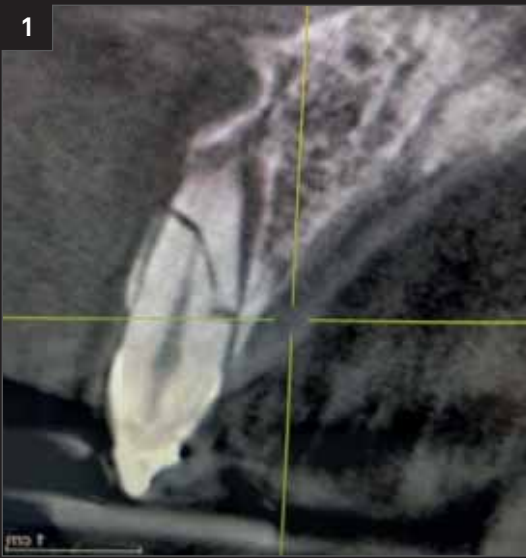
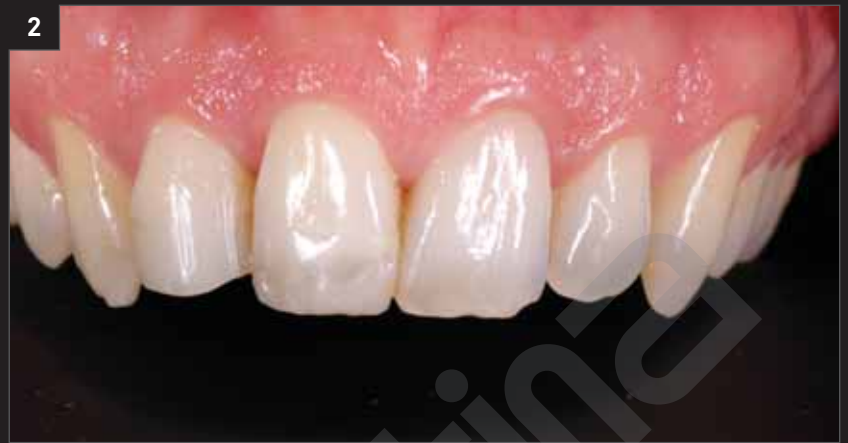
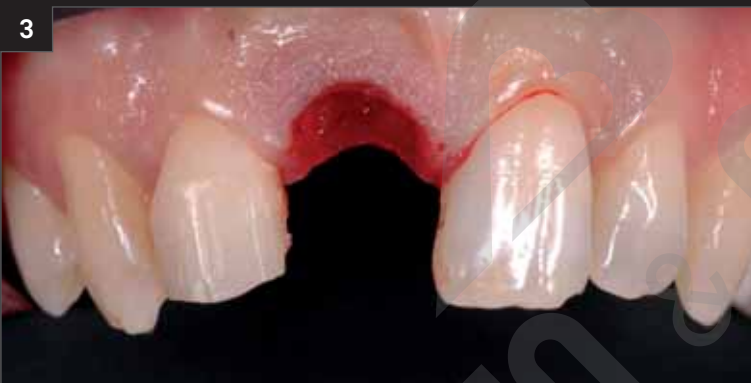
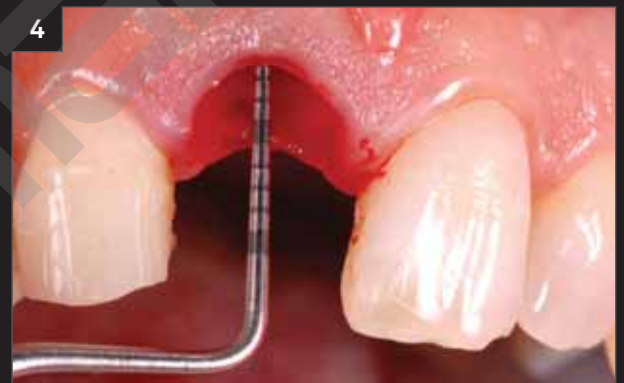
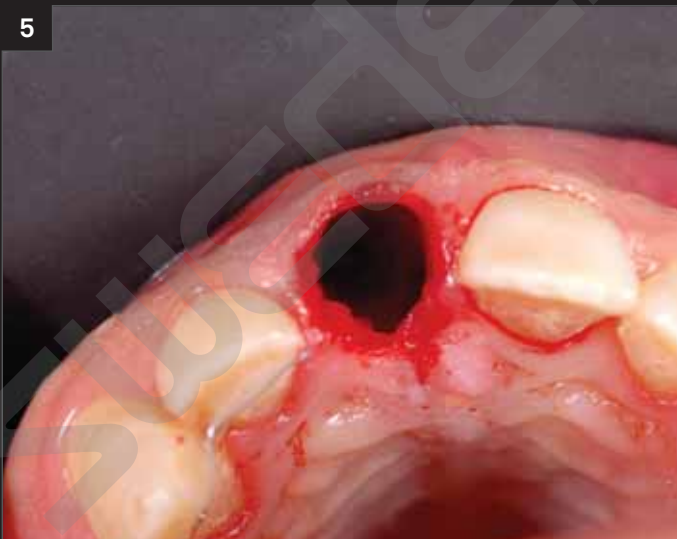
1. Initial radiographic situation, which shows the fracture of the element 1.1.
2. Initial clinical situation.
3. Atraumatic extraction of the fractured element is performed together with the debridement of the alveolus.
4. Probing of the residual bone crest, that detects a partial lack of the vestibular bone wall.
5. Preparation of the implant site with dedicate drills, taking care to engage the palatal bone wall.
6. After having verified the correct preparation of the implant site in the three planes of the space, a Prama RF 4.25x13 mm implant is inserted.

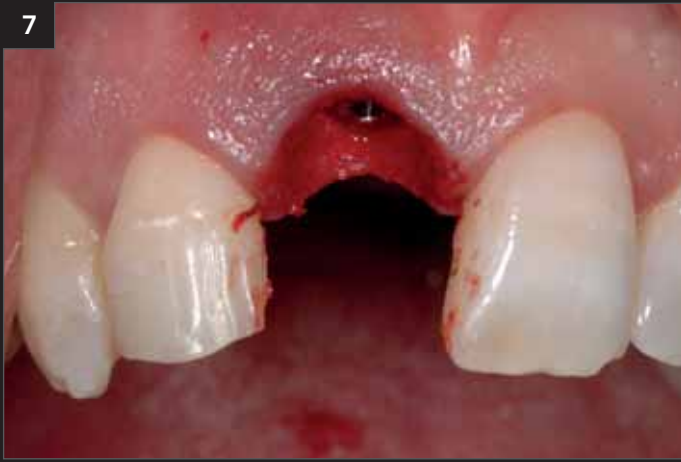
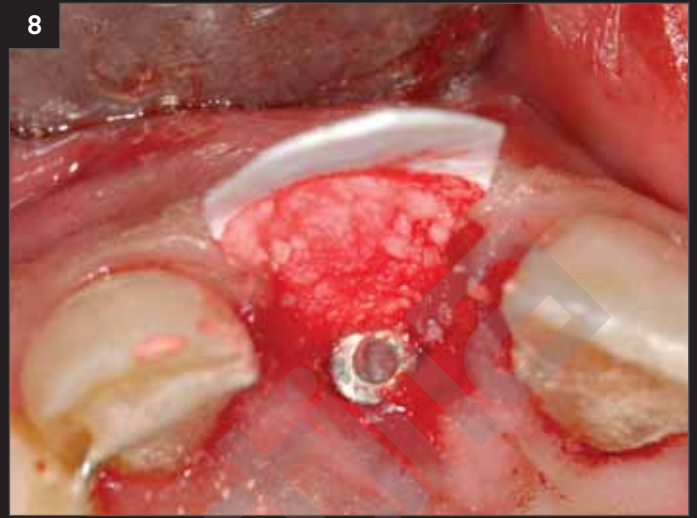
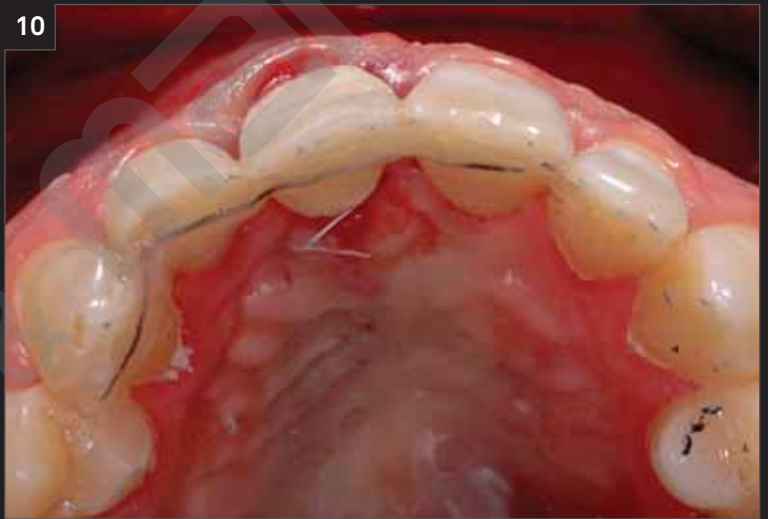
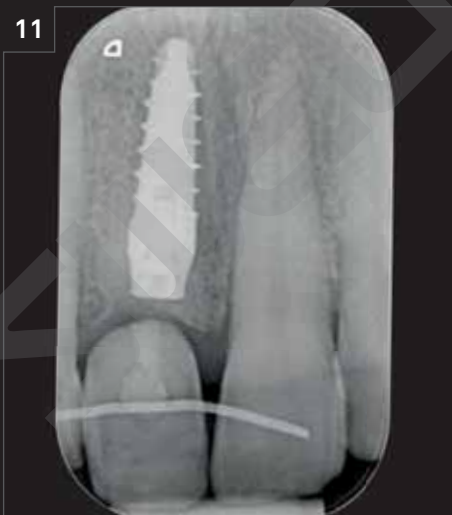
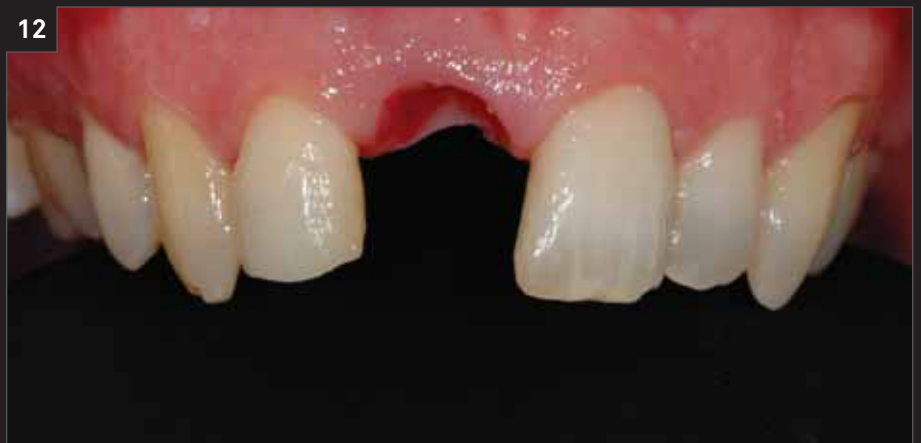
7. Vestibular view of the implant *in situ*.
8. To prevent the physiological collapse of the residual vestibular bone wall, already partially compromised, a porcine cortical bone resorbable membrane and porcine collagenated granular biomaterial are inserted.
9. Coronal side of the membrane sutured to protect the alveolus.
10. Positioning of the crown of the extracted element, appropriately shaped in its cervical portion and splinted on the palatal side of the adjacent teeth using an orthodontic thread and with adhesive technique.
11. Radiographic control at the time of the surgery.
12. Second surgery after 4 months.

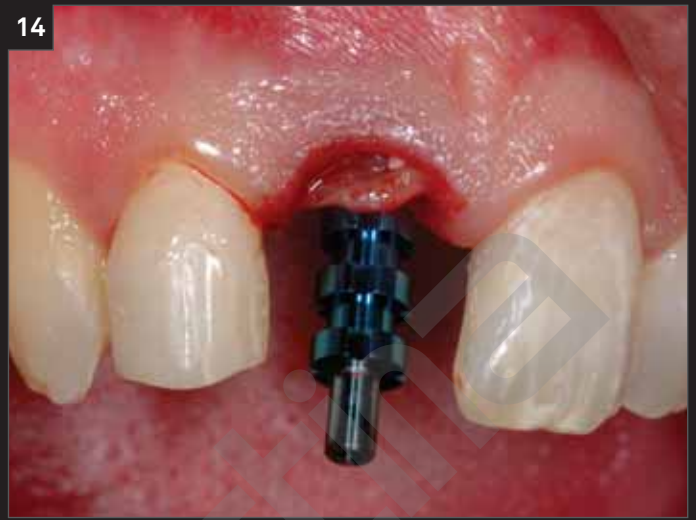
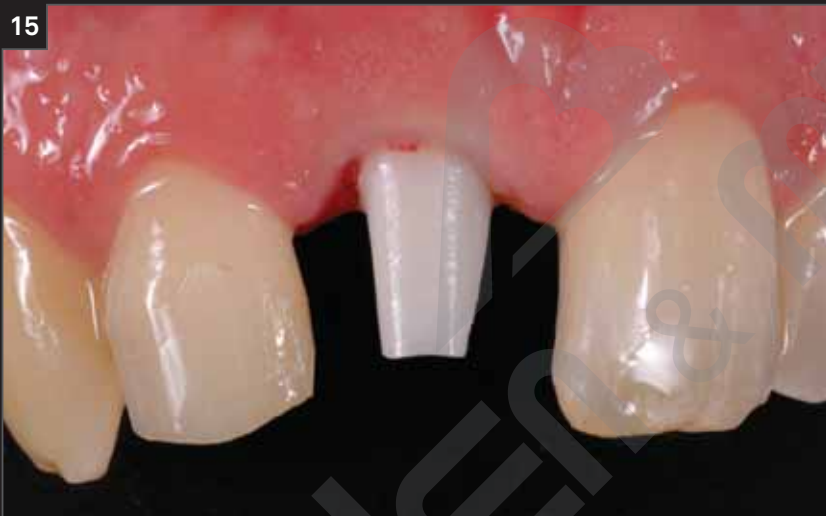
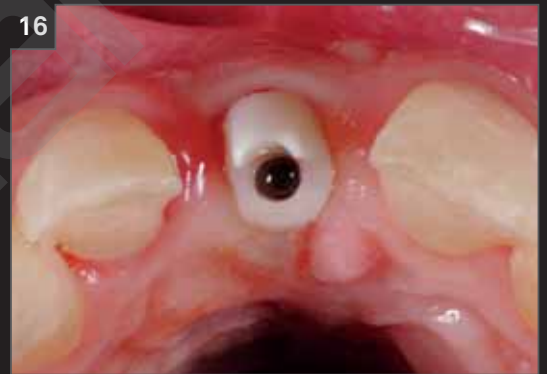
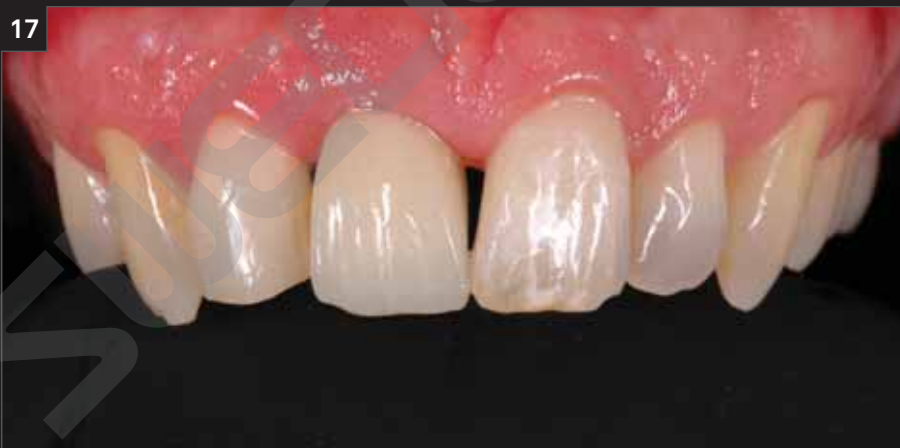
13. The cover screw is exposed through a semi-lunar incision.
14. Precision impression taking.
15. Frontal view of the zirconia post *in situ*.
16. Occlusal view of the zirconia post *in situ*.
17. In the same session a temporary crown is placed to shape the tissues.

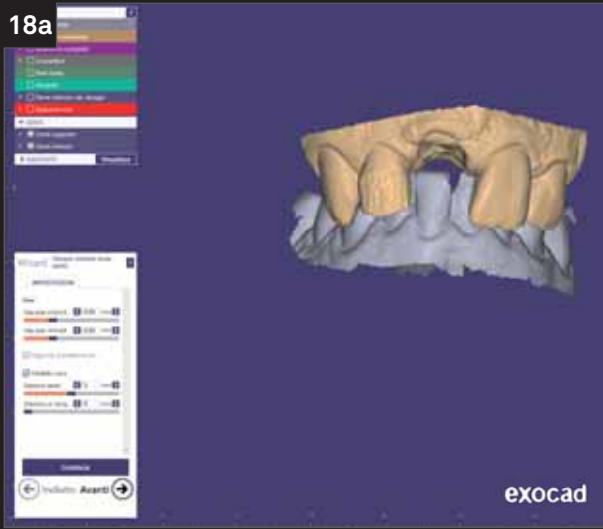
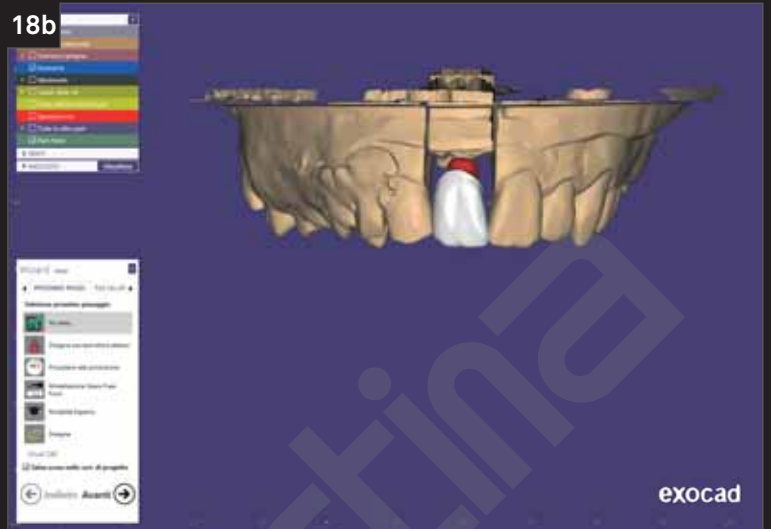
18. CAD-CAM design of the definitive crown.

19. Detail of the healing of peri-implant tissues at the time of the definitive crown delivery: residues of particulate material incorporated in the vestibular soft tissues without clinical signs of inflammation confirm a favorable healing.

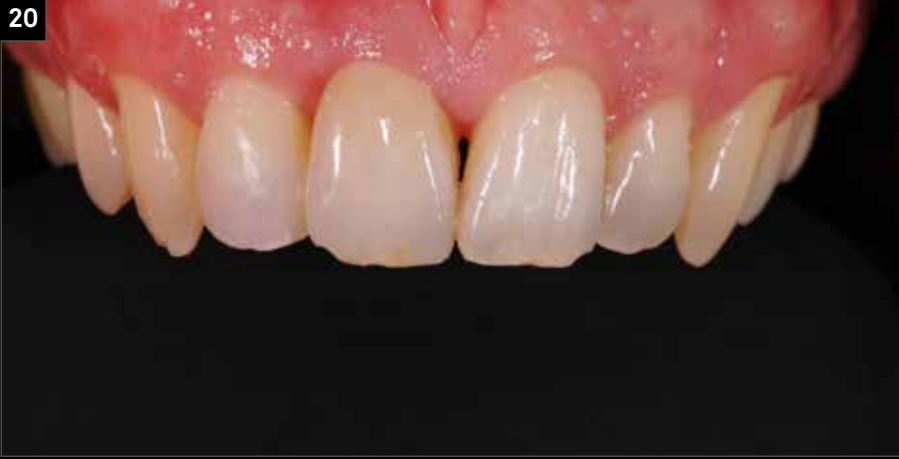
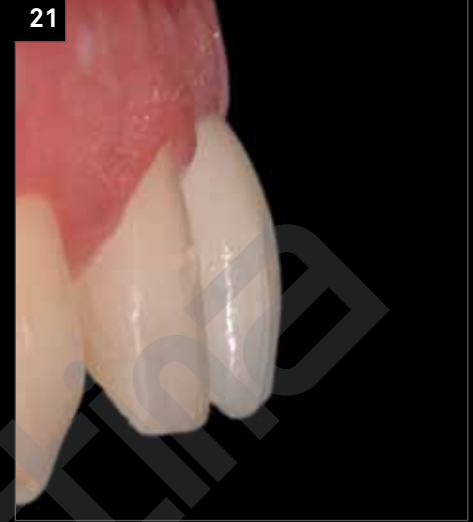
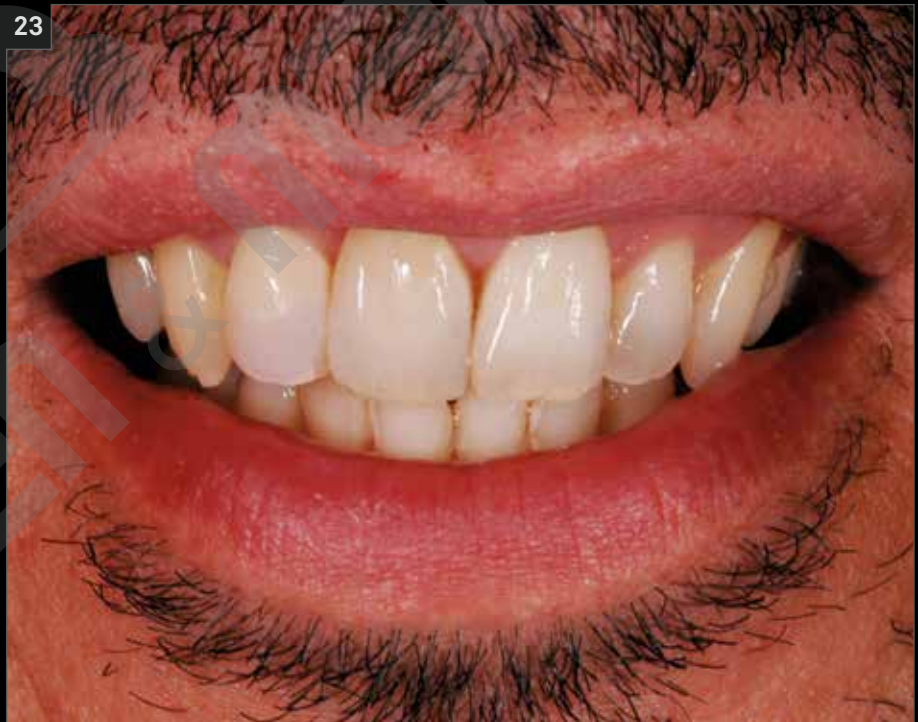
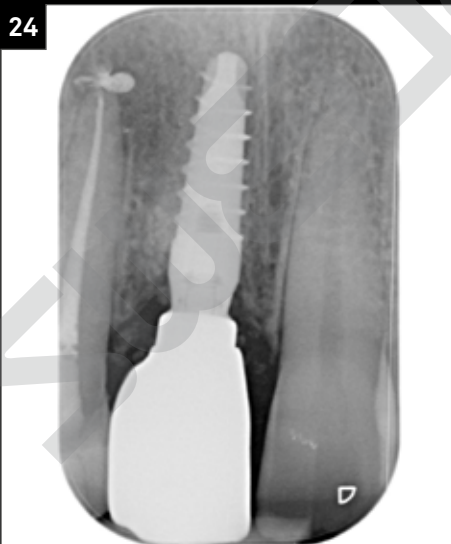
- 20. Definitive crown in lithium disilicate, cemented with resin cement.
- 21. Detail of the healing of the tissues.
- 22. Cone Beam at 6 months: the bone thickening of the buccal bony wall, essential for long-term soft tissue maintenance, is evident.
- 23. Clinical follow up at 12 months.
- 24. Radiographic follow up at 12 months.
