Peri-implant tissue remodeling after guided bone regeneration and late implant placement in aesthetic zone: 2-year clinical and radiographic outcomes

Dr. Davide Guglielmi, Dr. Roberto Castellano, D.T. Massimo Marzetta,
Solbiate Olona (VA), Italy

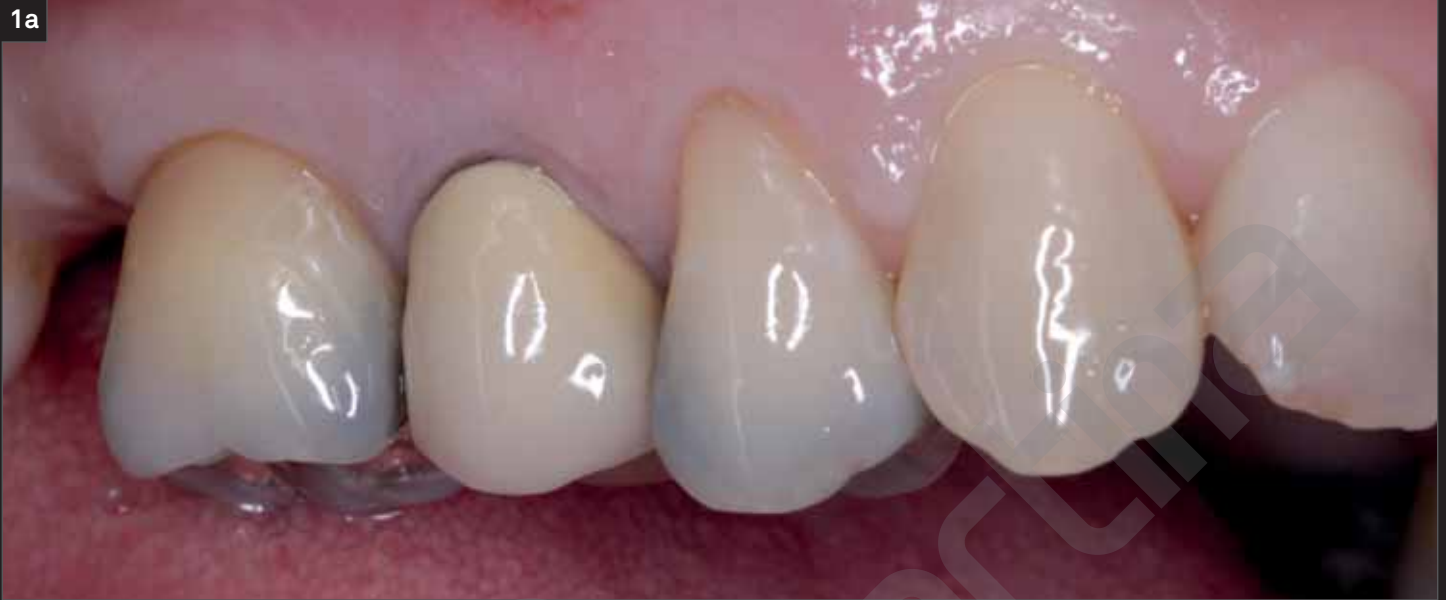
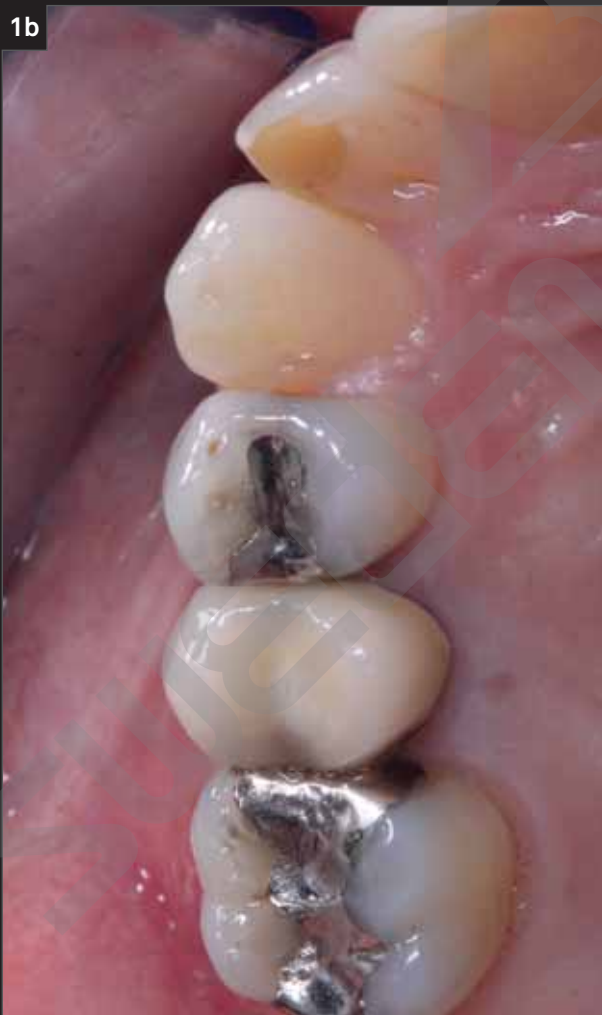
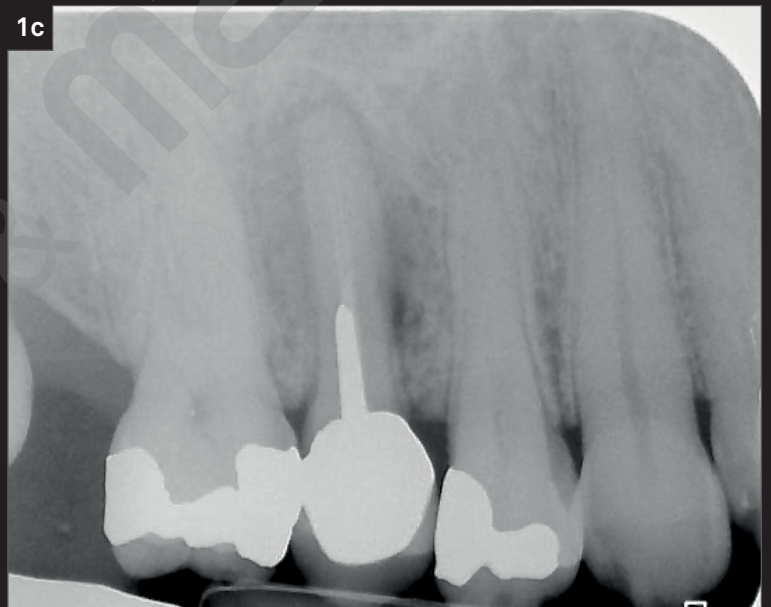
1. Initial clinical and radiographic images of the crown on the 1.5. The periapical radiograph shows the radiolucent lesion around the third middle and apical of the root.

The patient, a 48-year old female, came to our observation referring pain in the right maxilla. The clinical examination showed a fistula in the buccal mucosa of element 1.5. This element supported a crown for more than ten years and was hypermobile at the palpation. The radiographic examination shows a radiolucent area at the level of the middle third and apical third of the root.

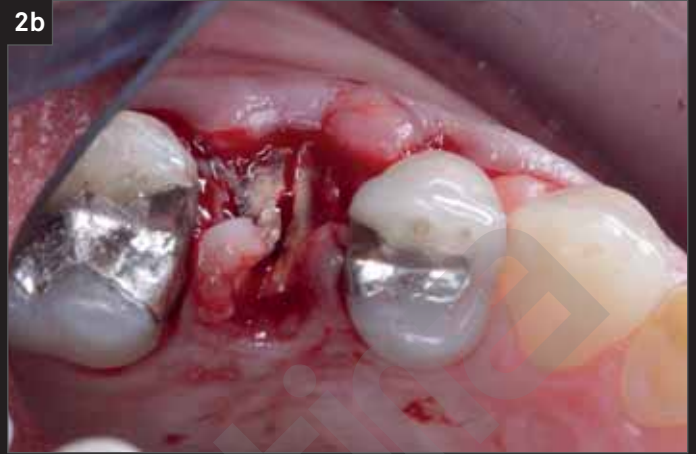
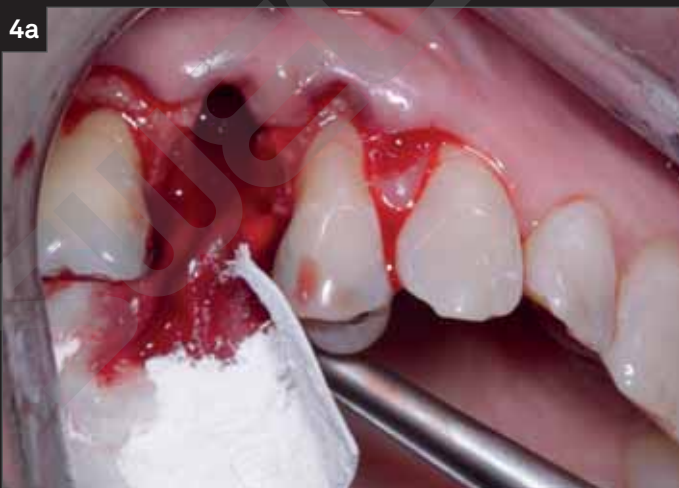
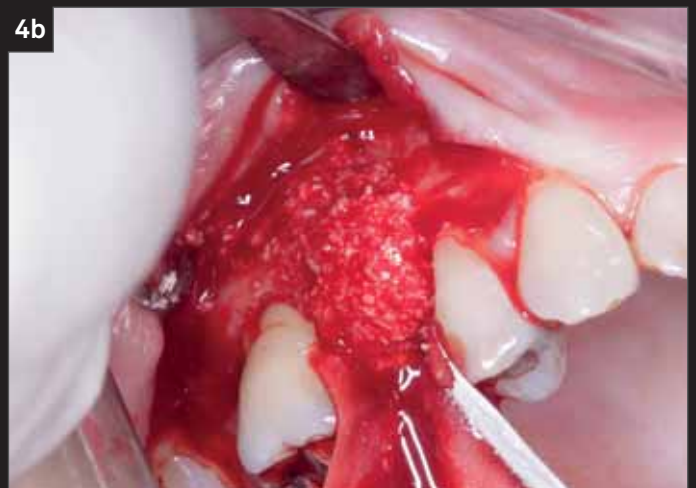
2. First surgical step: an intrasulcular flap is raised and the root fracture is exposed after removing the crown.
3. At the removal of the fractured root, the bone defect is evident.
4. Bone regeneration: the alveolus is filled with deproteinized bovine bone particles covered with a resorbable collagen membrane.

During the first surgical step, the extraction was performed, and the bone defect was filled with deproteinized bovine bone mineral particles, covered with a resorbable collagen membrane.

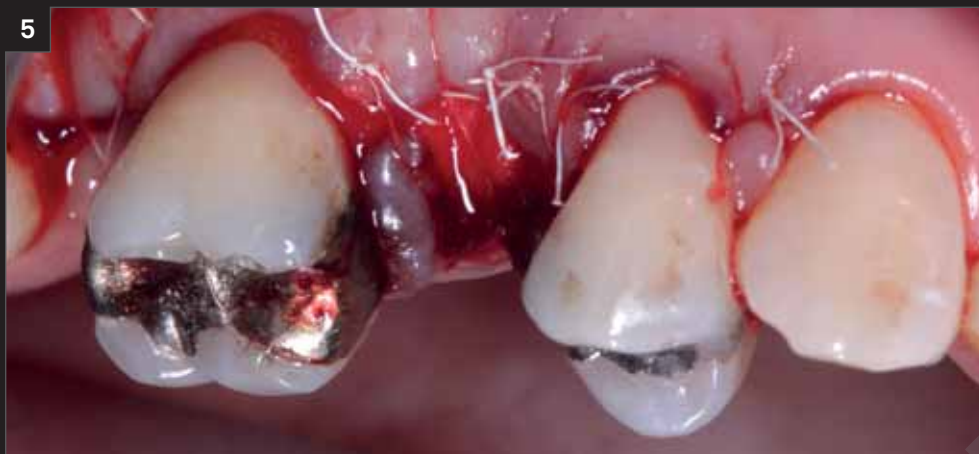
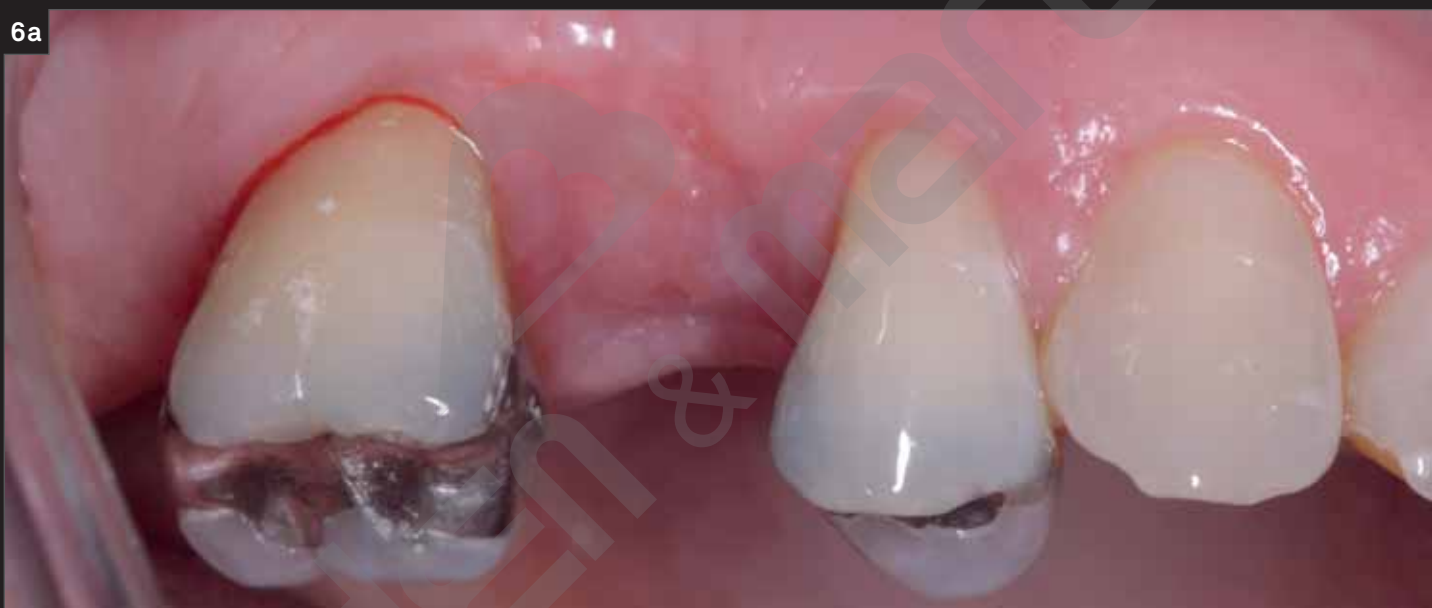
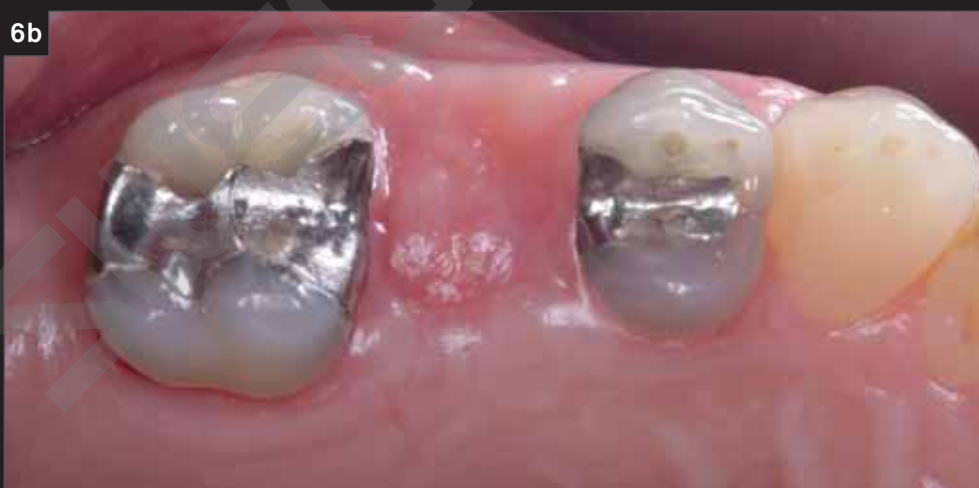
5. Tension-free secondary wound closure with PTFE sutures. Sutures are removed after 2 weeks.
6. Vestibular and occlusal view of the post-surgical site after 1 month from the augmentation material insertion: the initial phase of healing and the progressive volumes recovery can be appreciated.

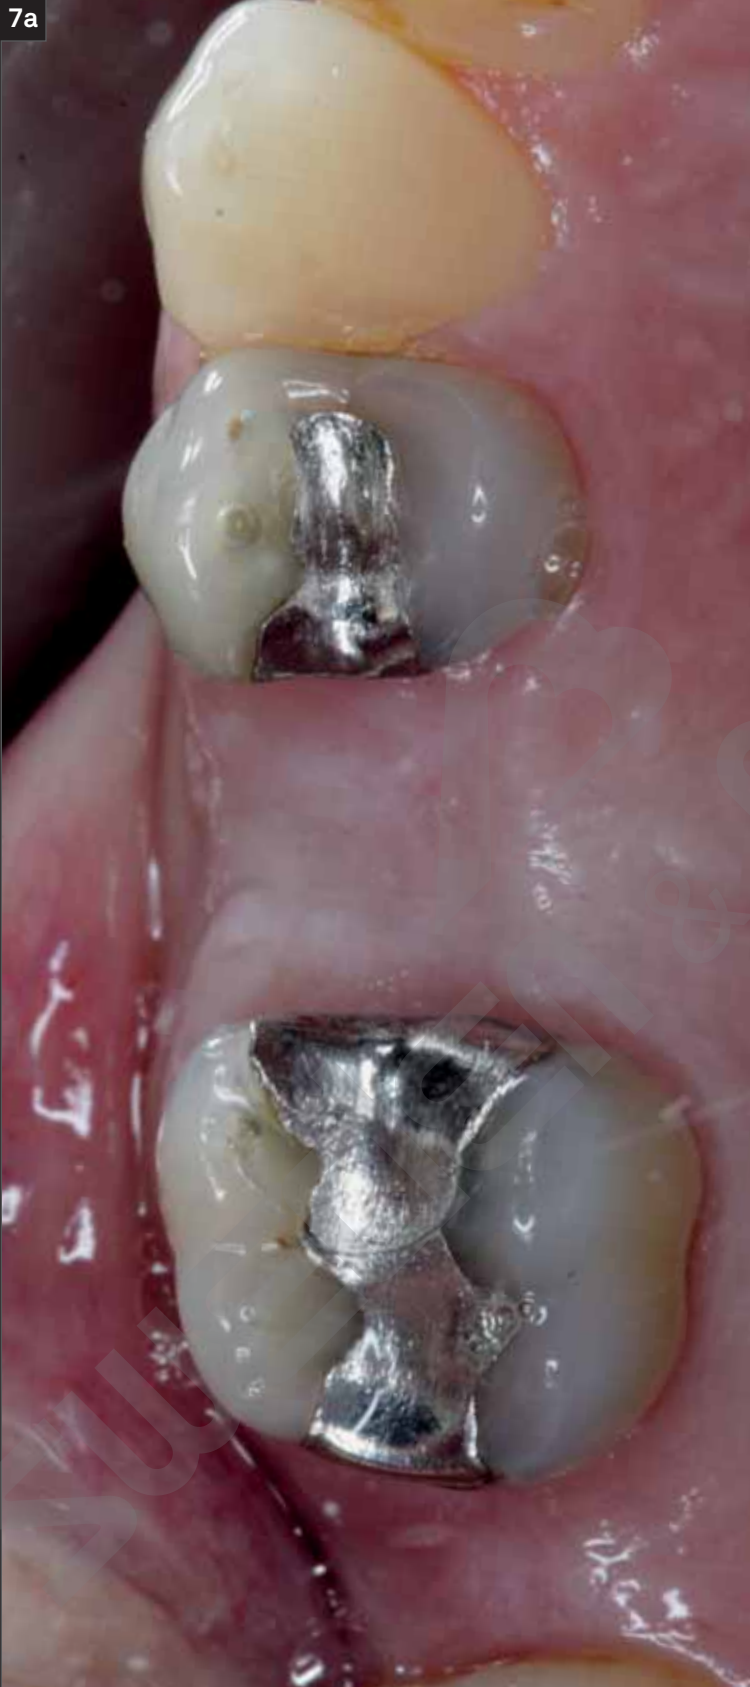
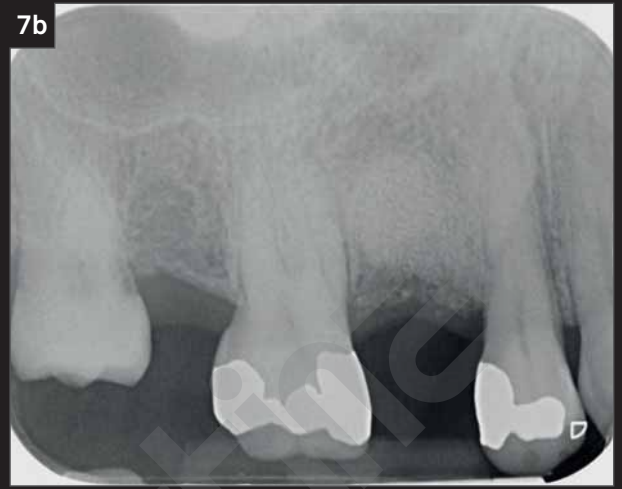
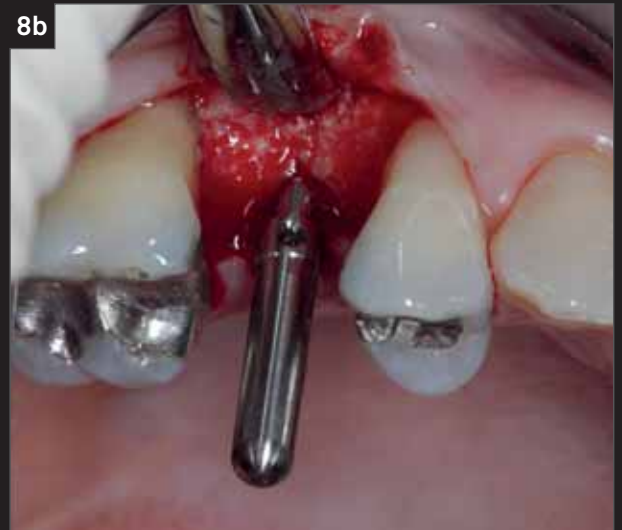
7. Radiographic and clinical images after 7 months from the regeneration: the radiographic examination shows adequate bone volume; the healing of the soft tissue is completed. Therefore, we decide to proceed with the second step of the surgery.
8. Second surgical step: the flap is open, observing that the bone volumes are regenerated. A parallelism pin is inserted after surgical site preparation, to verify the implant insertion axis.

After seven months, the second surgical step involved the crestal incision in the edentulous area and the insertion of a Prama implant in the regenerated site.

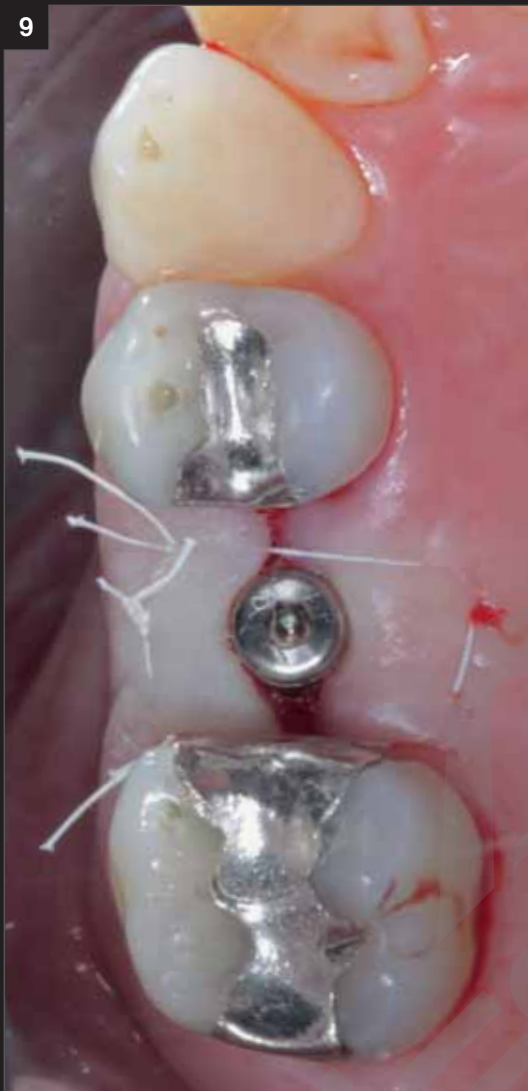
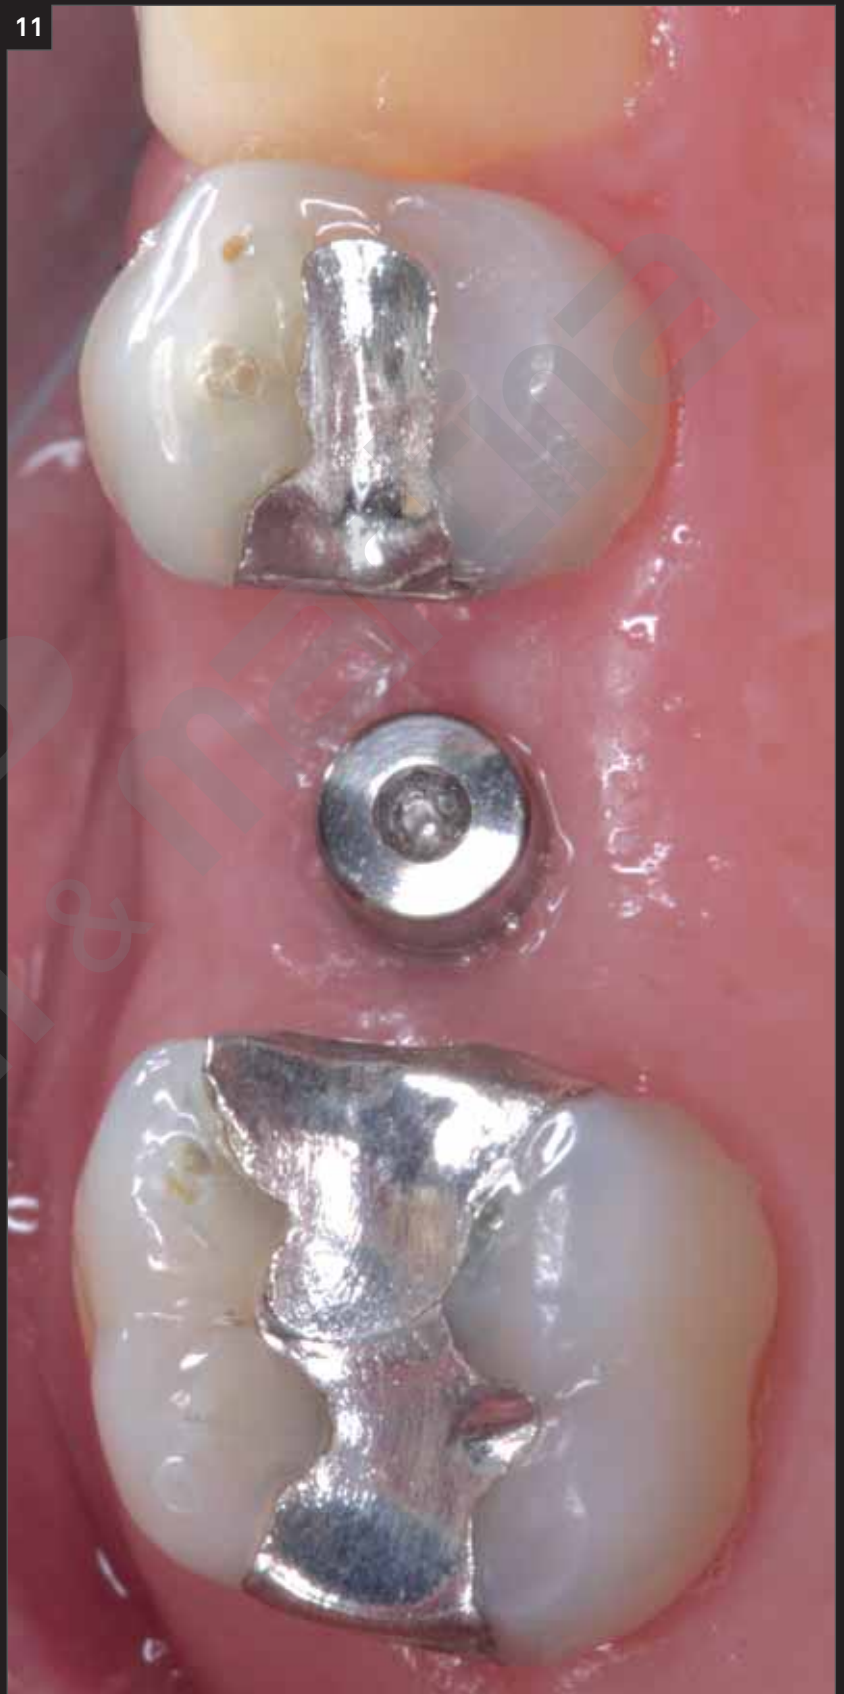
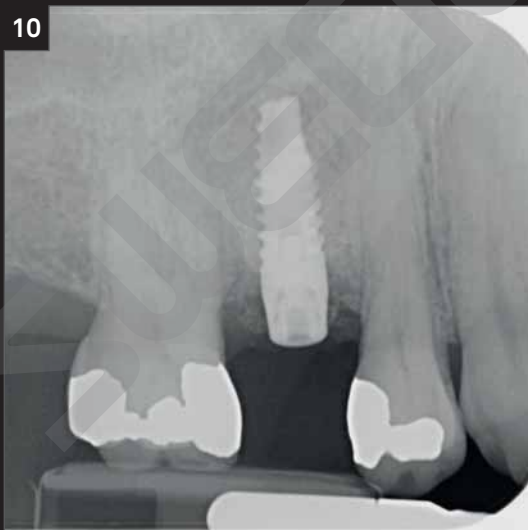
9. Prama implant in place and insertion of a surgical cover screw. The surgery is completed with a tension-free secondary wound closure with PTFE sutures; removed after 2 weeks.
10. Post-surgical radiograph to verify the correct insertion of the Prama implant.
11. 4 months after surgery, the volumes are restored, and the soft tissues look healthy.

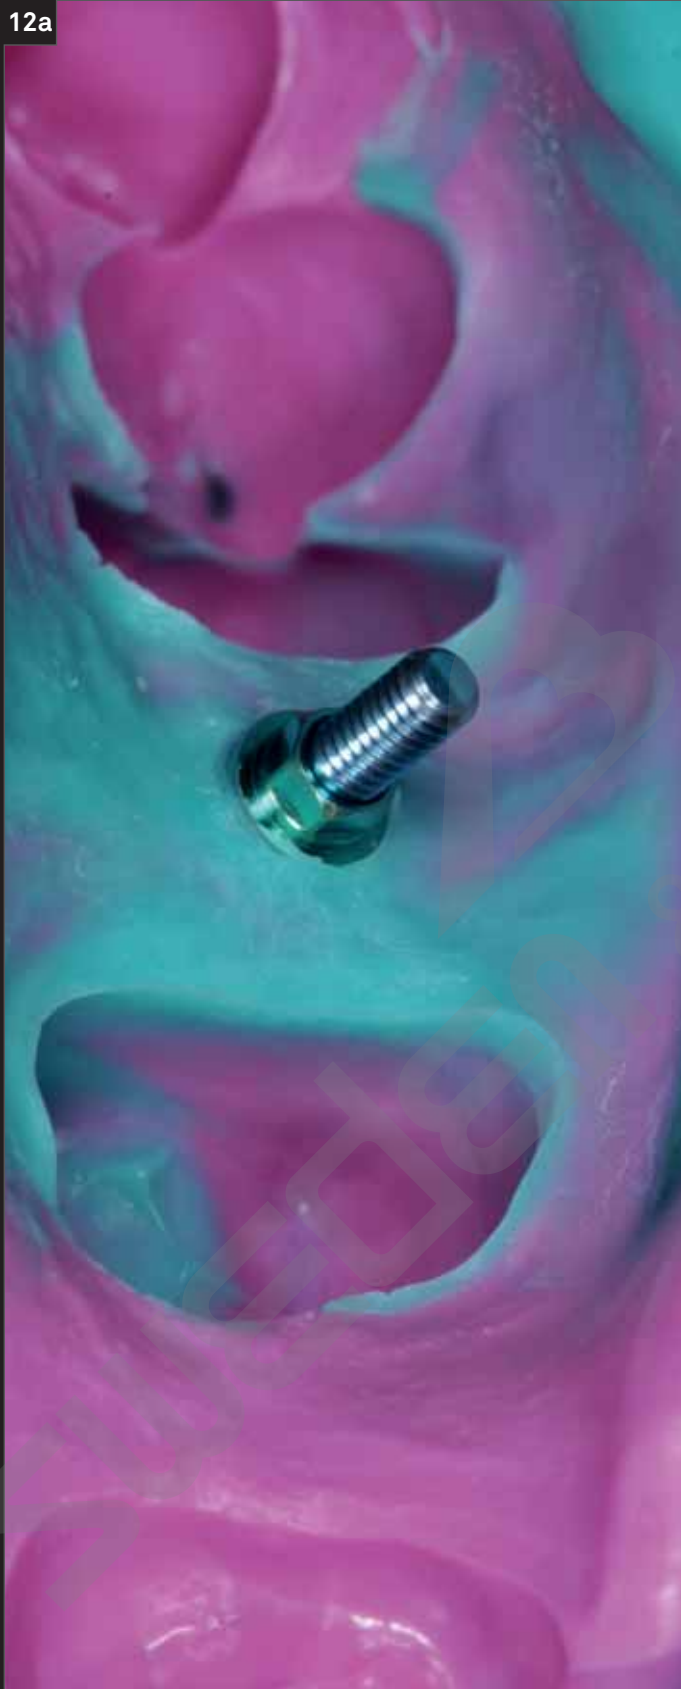
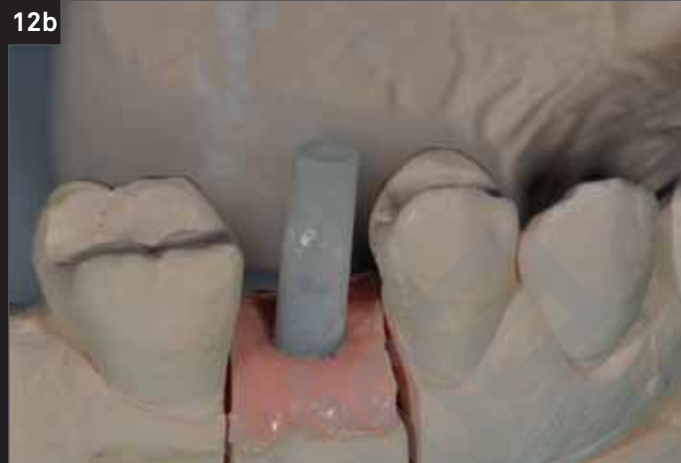
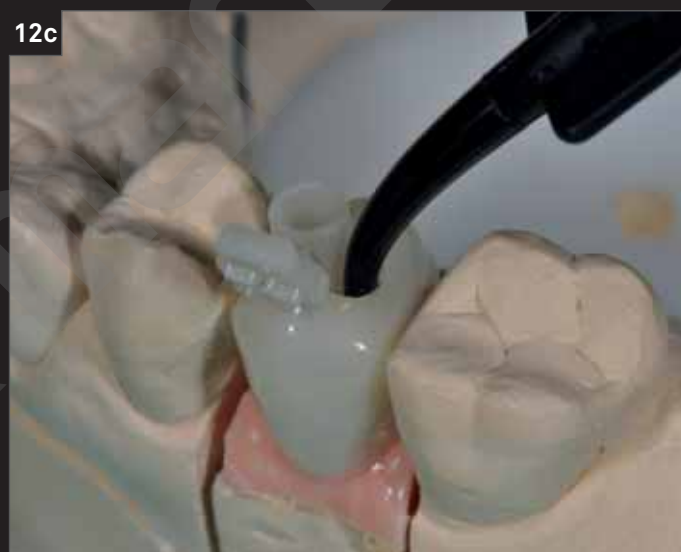
12. Impression and temporary crown production.

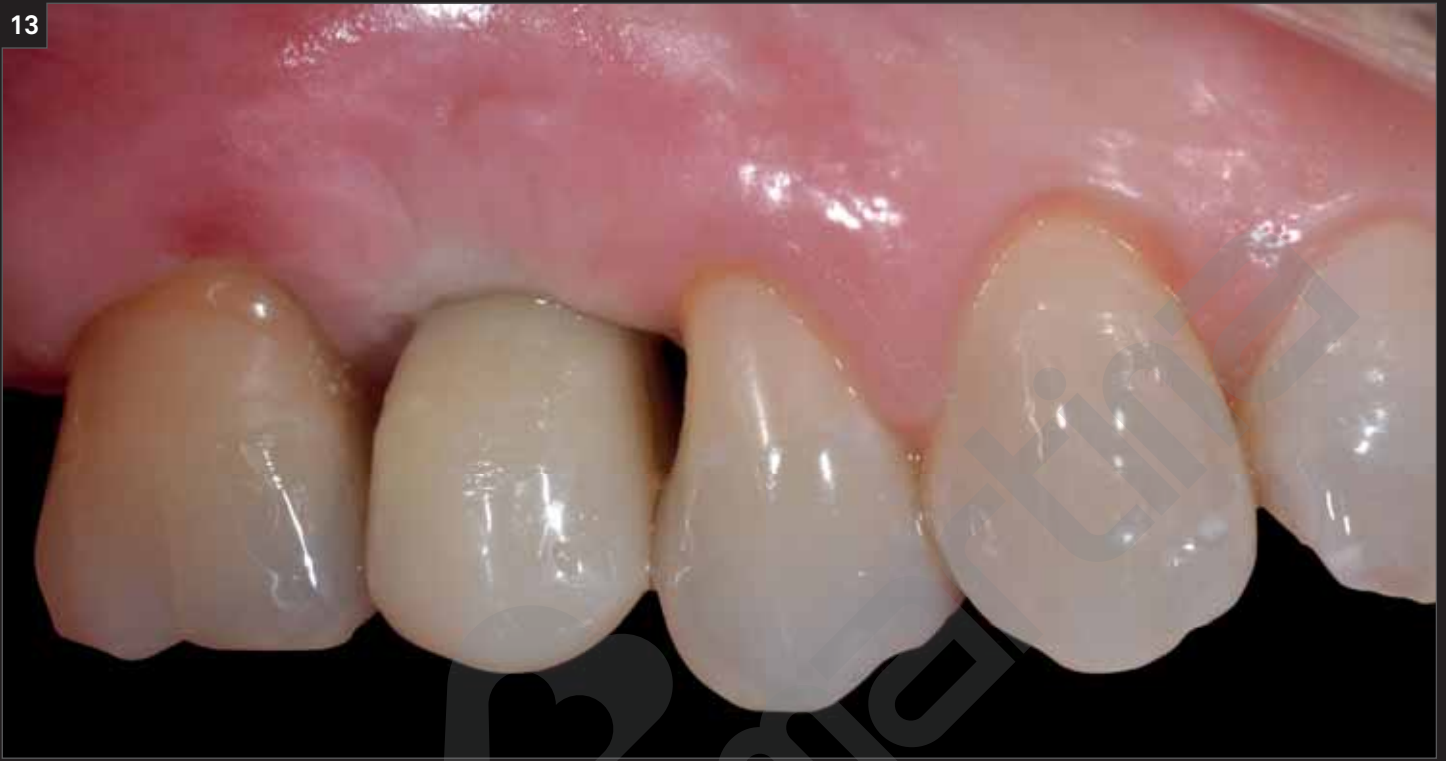
13

13. Temporary crown *in situ*: note the ischemia for the conditioning of the soft tissue through the progressive modification of the temporary crown.

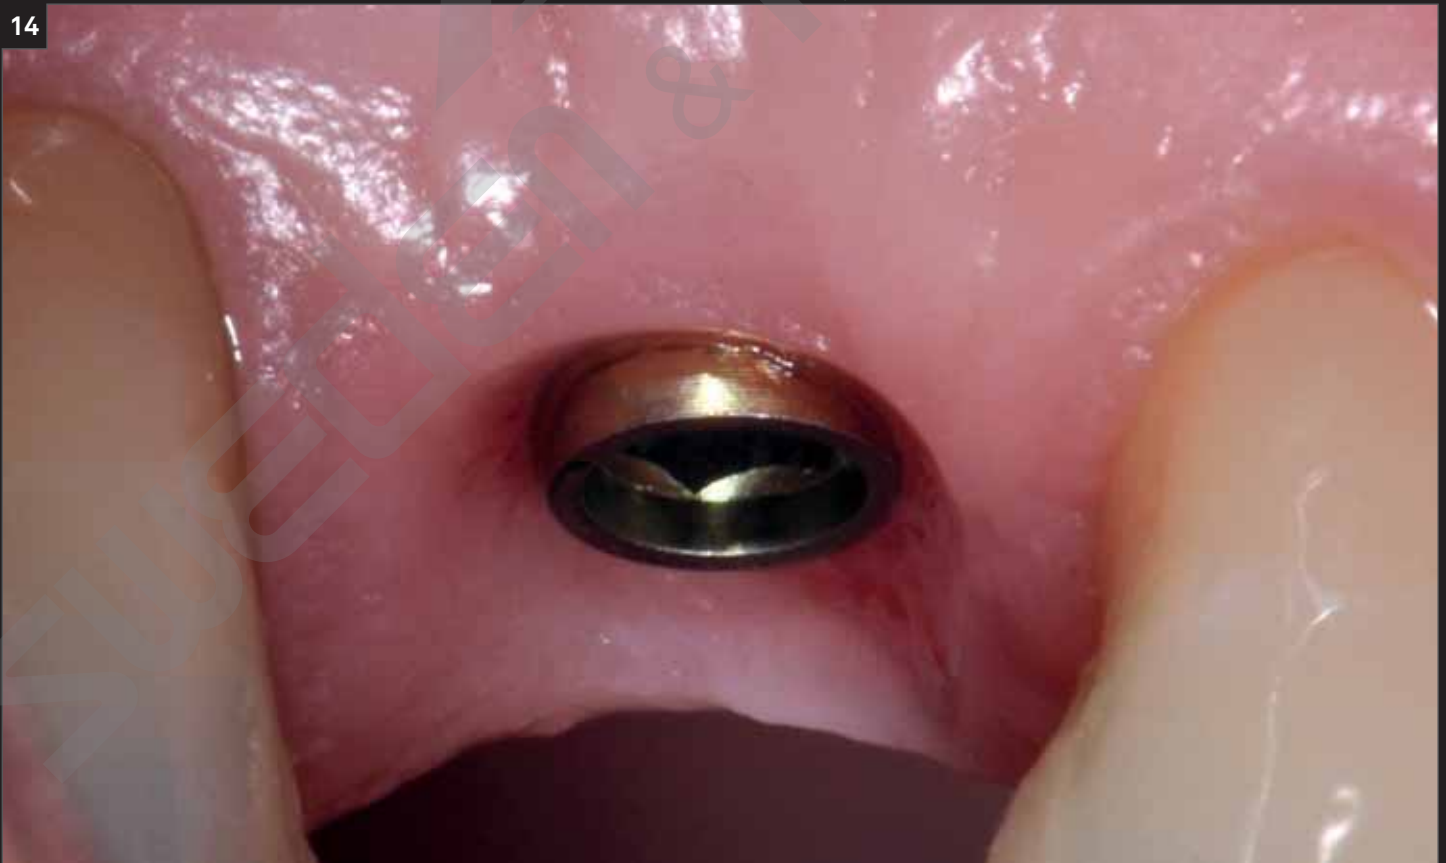
14

14. 4 months after the surgery, the site is open to take the final impression: the excellent healing of peri-implant soft tissue can be appreciated.

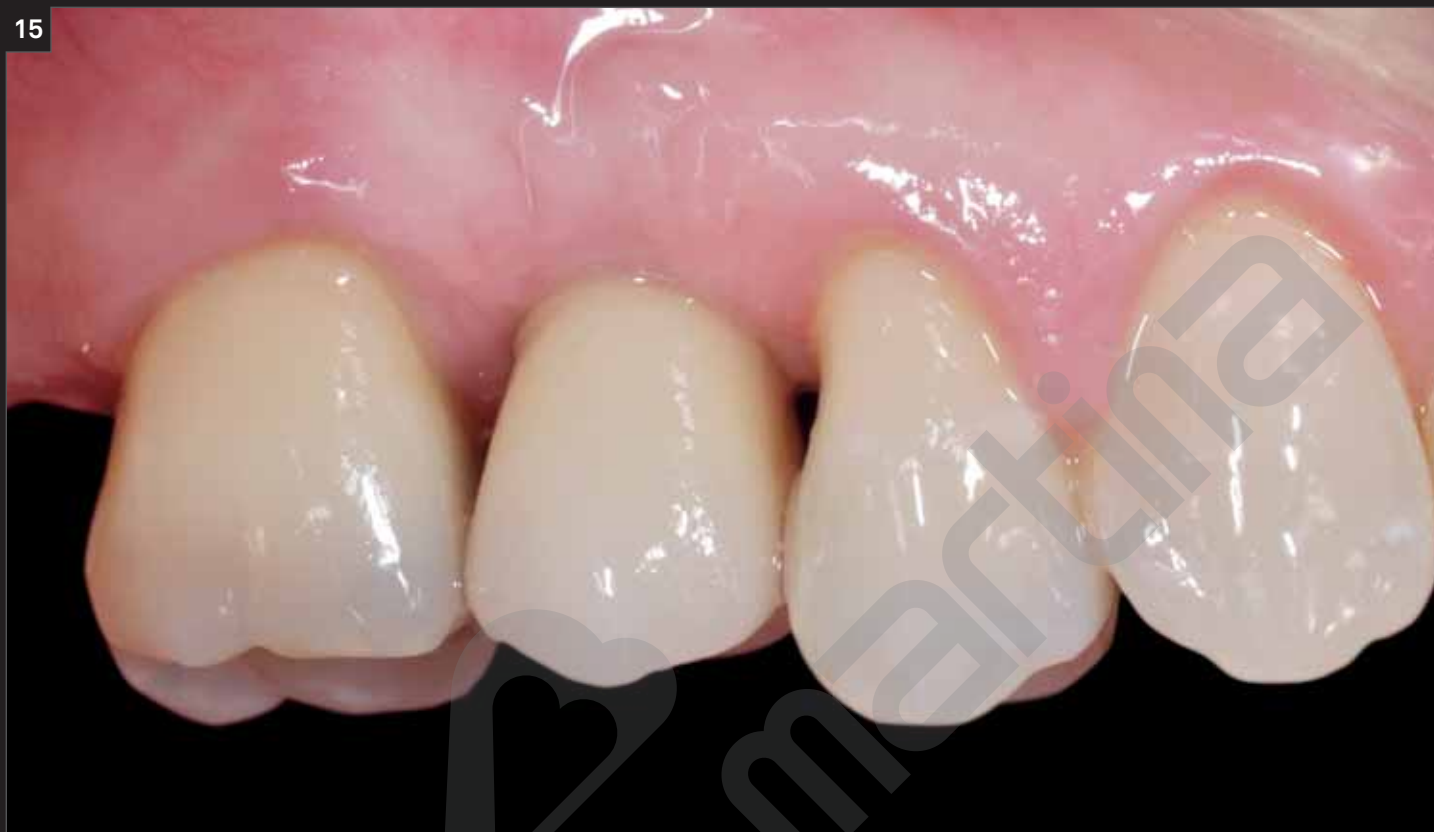
15

15. After 4 months from the surgery, the final crown is delivered.

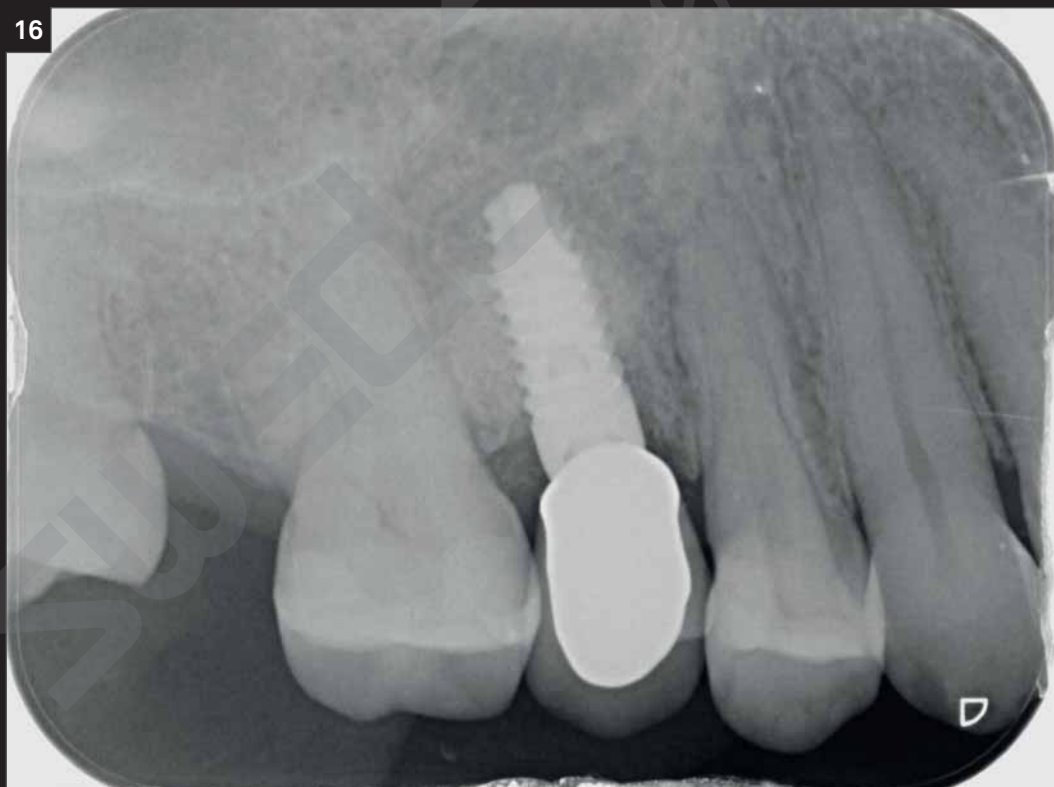
16

16. Radiographic image after 1 year from the extraction: peri-implant bone volumes are stable over time.

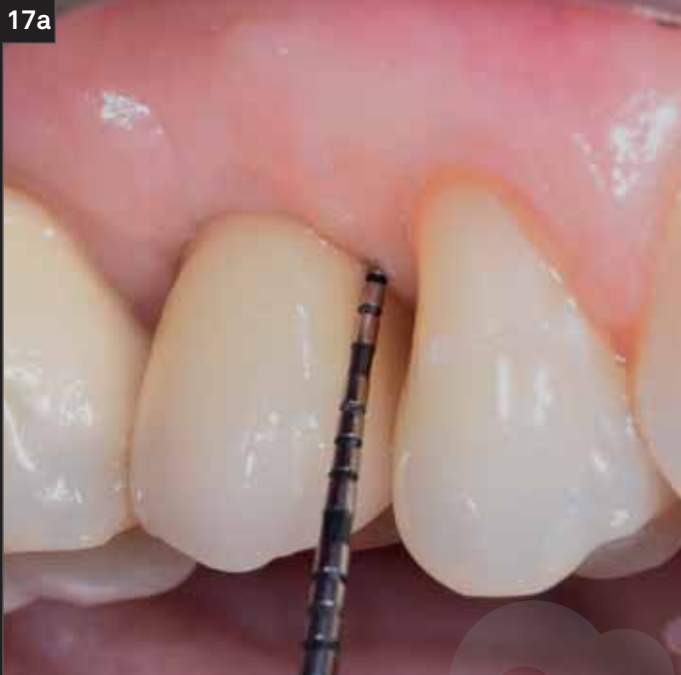
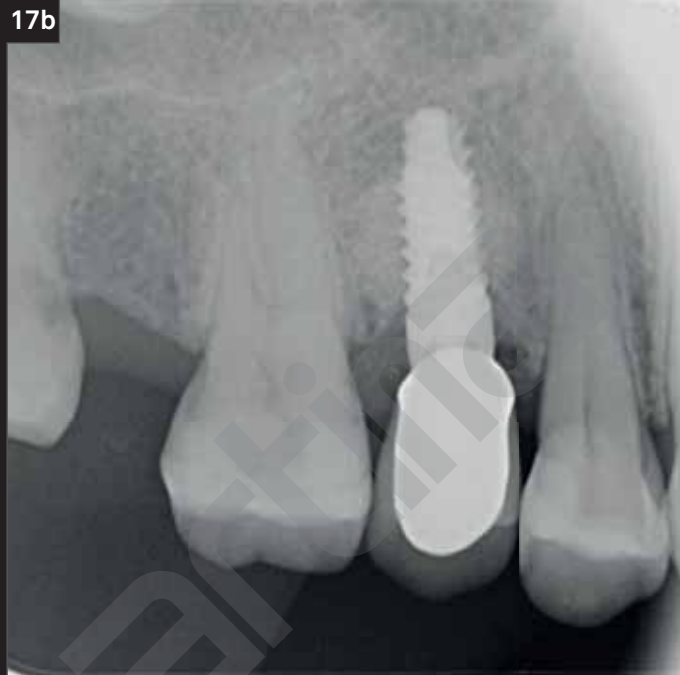
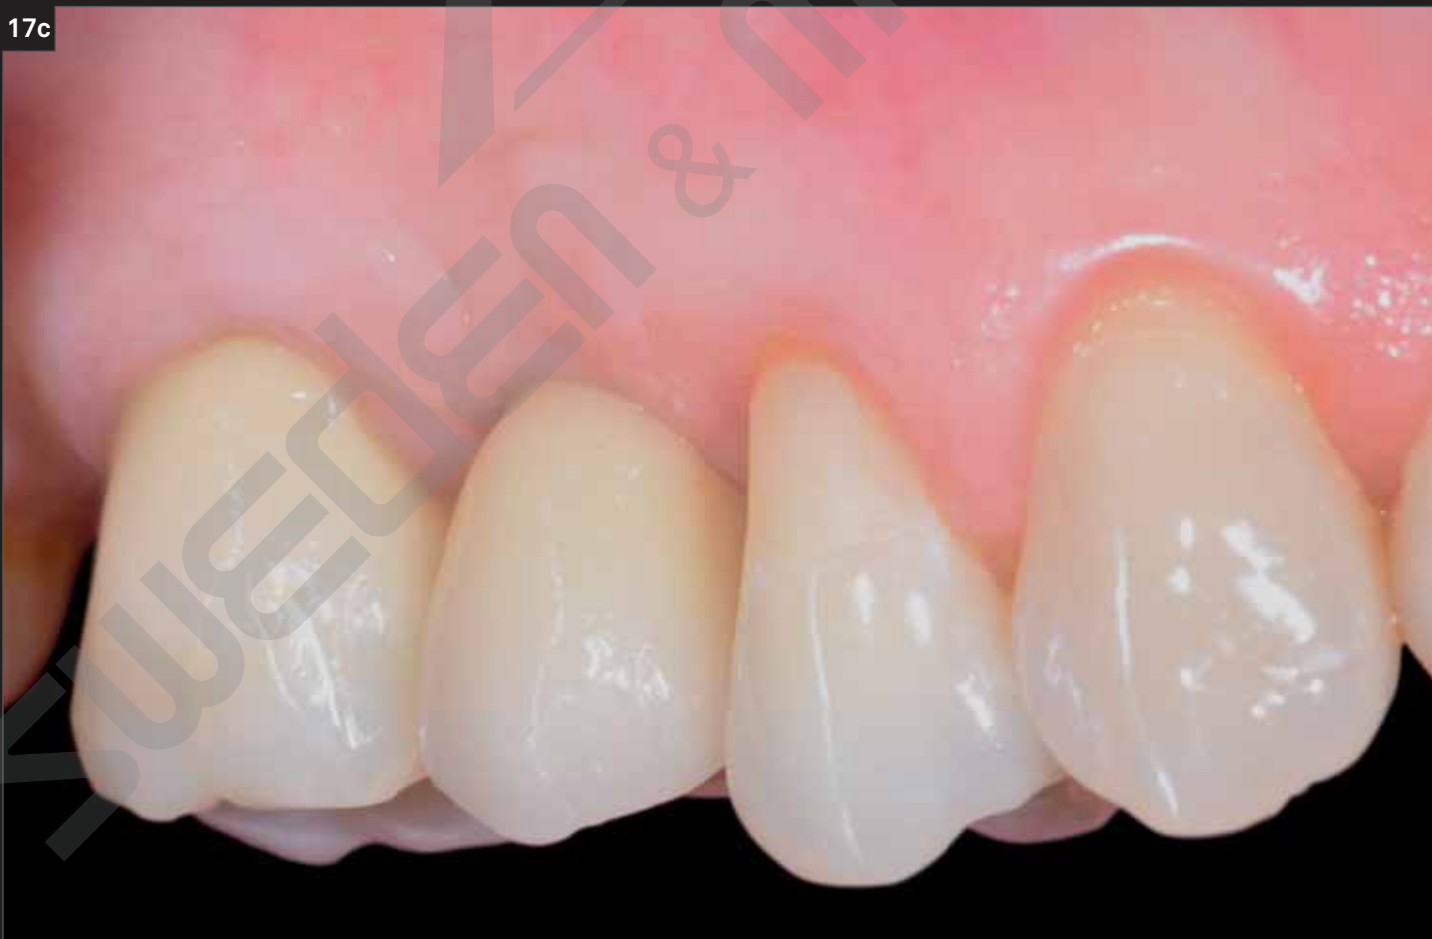
17. 2 years follow-up. A proper maturation of the peri-implant tissues can be appreciated, with a subsequent optimal aesthetic result. The radiograph confirms the bone volumes maintenance. Physiological probing and negative bleeding indexes are evidence of the excellent peri-implant connective density around the convergent UTM neck of Prama implant.

In this case, it seems that all the primary and secondary goals was achieved and confirmed at the 2 years follow up.
